NASA TM X-1484

**FLIGHT TEST OF A 40-FOOT-NOMINAL-DIAMETER MODIFIED RINGSAIL
PARACHUTE DEPLOYED AT A MACH NUMBER OF 1.64 AND A
DYNAMIC PRESSURE OF 9.1 POUNDS PER SQUARE FOOT**

**By Clinton V. Eckstrom, Harold N. Murrow,
and John S. Preisser**

**Langley Research Center
Langley Station, Hampton, Va.**

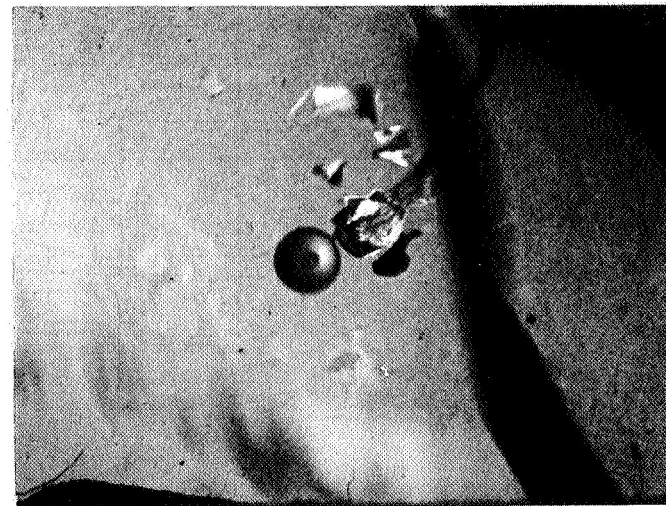
(a) Deployment.

Figure 11.- Onboard camera photographs of parachute performance during deployment and inflation sequence.

Extensive examination of the aft camera film showing the parachute deployment sequence gave no indication of any item which would have prevented proper inflation of the canopy. Selected frames from this film showing ejection, line stretch, partial inflation, and twisting of the suspension lines are presented in figure 11.

As mentioned previously, the time from mortar firing to suspension line stretch was 0.45 second; therefore, an average ejection velocity of 114 feet per second (35 meters per second) was achieved which indicated normal mortar operation. The test parachute began inflation immediately after deployment but never reached the full-open condition. The canopy remained partially inflated but did not spread the suspension lines enough to prevent the spinning payload from twisting the suspension lines in addition to the riser and the bridle system. This twisting of the suspension lines definitely hampered inflation of the canopy at any later time. On previous flights where canopy inflation was rapid, the twists had been contained within the riser and bridle system and had not affected parachute performance.

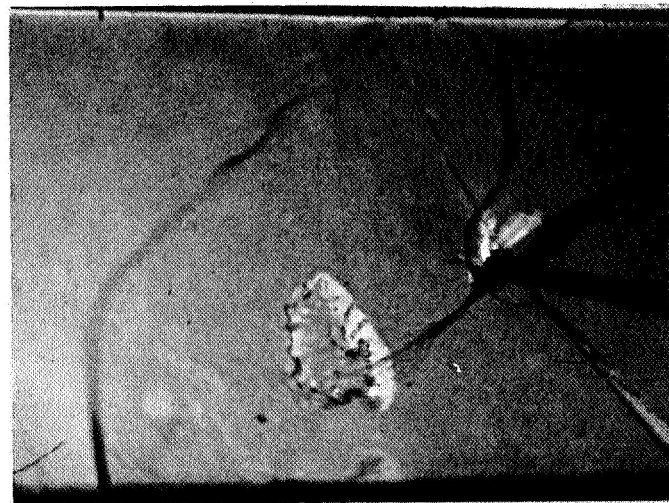
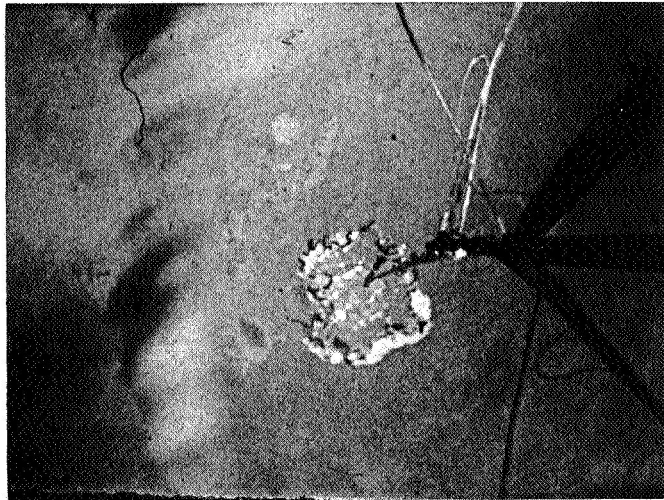
(b) Partial inflation.

Figure 11.- Continued.
